Limited Visual Dam Safety Inspection Summary Report

MA-076

Maui Reservoir 33

Limited Visual Dam Safety Inspection Conducted on: 03 April 2006

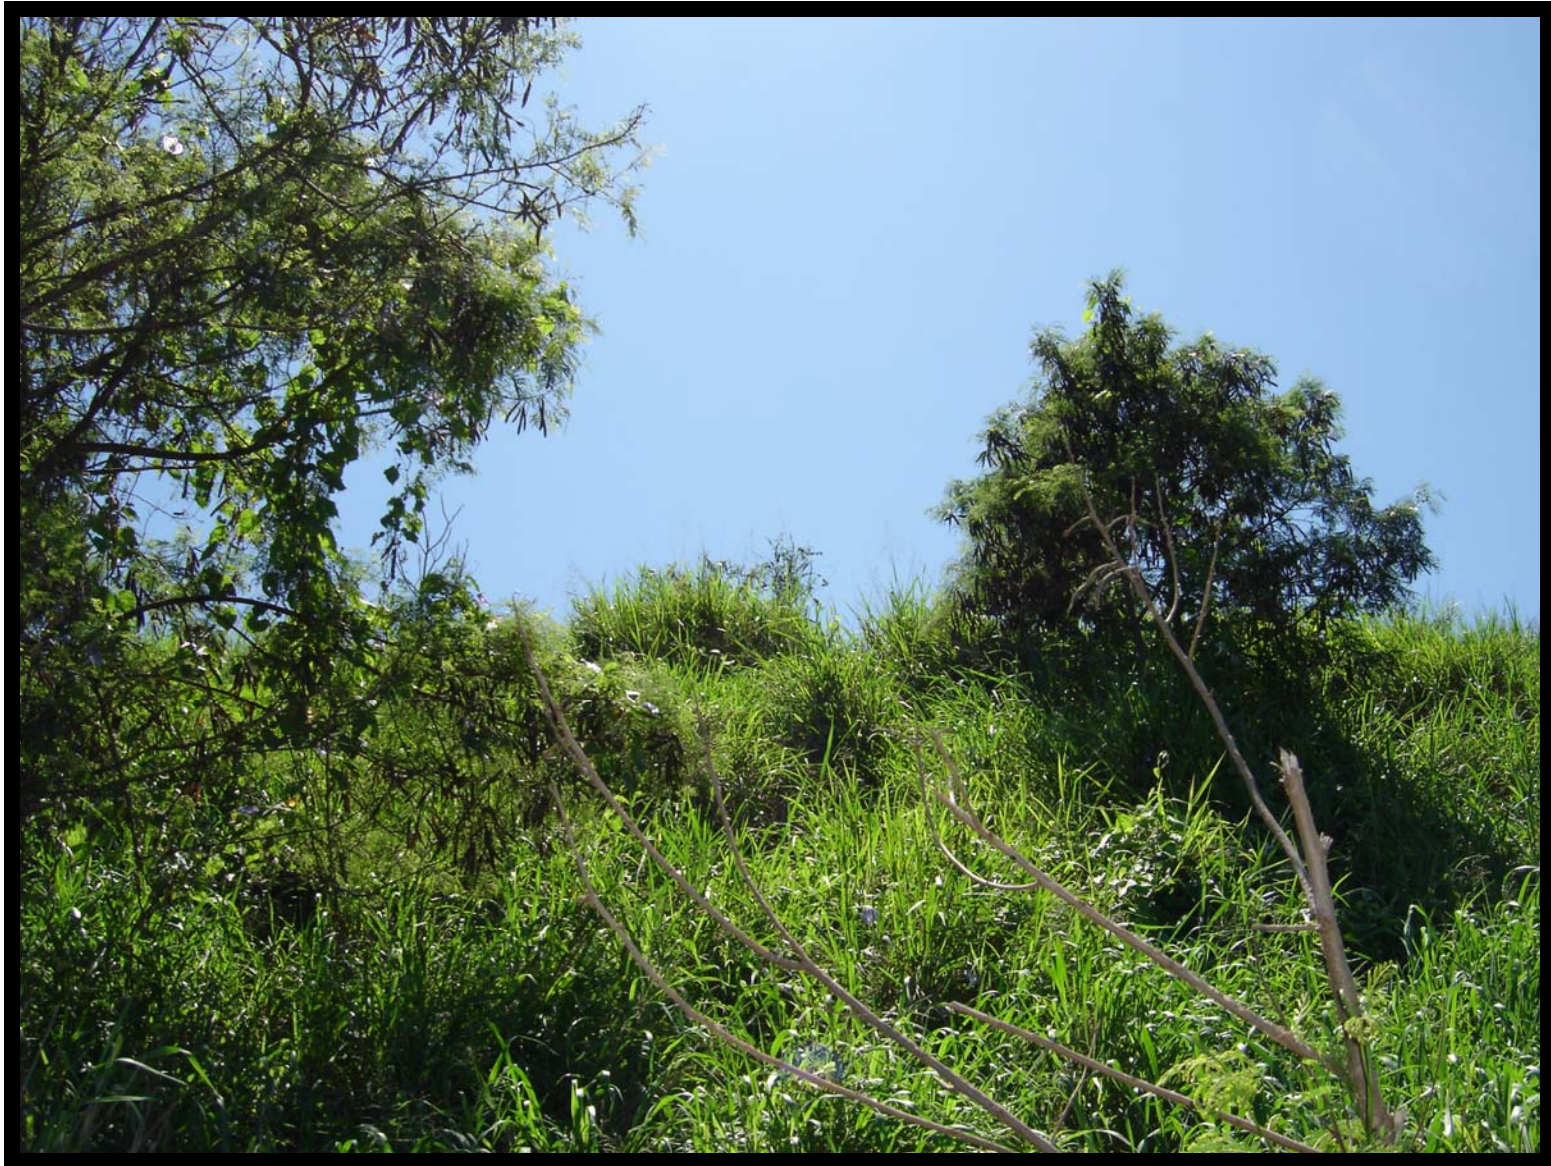
076 Crest Growth - View of crest of dam and numerous trees and overgrowth.

- a. The dam crest appeared to be in fair to poor condition and requires corrective action. There is heavy overgrowth of vegetation that should be removed to facilitate inspection.
- b. Access along the crest was difficult due to vegetation overgrowth.
- c. Portions were not visible due to high grass and bush visual inspection. Clear high vegetation and maintain low to enable easy visual inspection.
- d. Tree(s) were observed on the dam embankment. Trees have been identified as the probable cause of piping failures, and can possibly cause severe damage to the embankment if they are uprooted during high winds. Corrective action is required to remove the tree hazards from the dam. Acceptable remedies include removal of the tree and its root structure down to a 2" diameter and

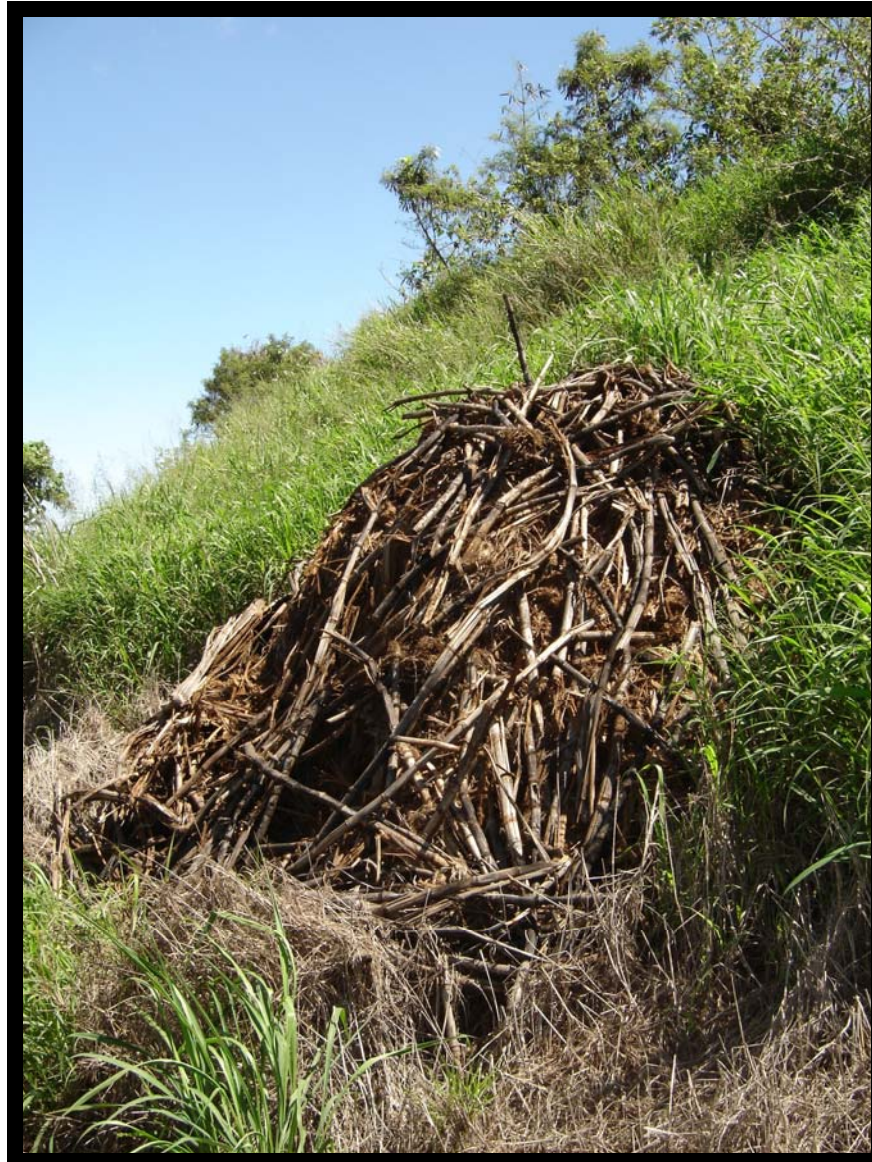
076 Downstream embankment cane
and trees at top of slope

- a. The downstream slope appeared to be in fair to poor condition and requires corrective action. Remove trees.
- b. The down stream slope was not visible due to high grass and bush visual inspection. Clear high vegetation and maintain low to enable easy visual inspection.
- c. Tree(s) were observed on the downstream slope. Trees have been identified as the probable cause of piping failures, and can possibly cause severe damage to the embankment if they are uprooted during high winds. Corrective action is required to remove the tree hazards from the dam. Acceptable remedies include removal of the tree and its root structure down to a 2" diameter and reconstruction the damaged embankment section. All repair work shall be accomplished as per the requirements of licensed geotechnical or structural engineer. Routinely monitor the damaged area for signs of settlement and seepage.

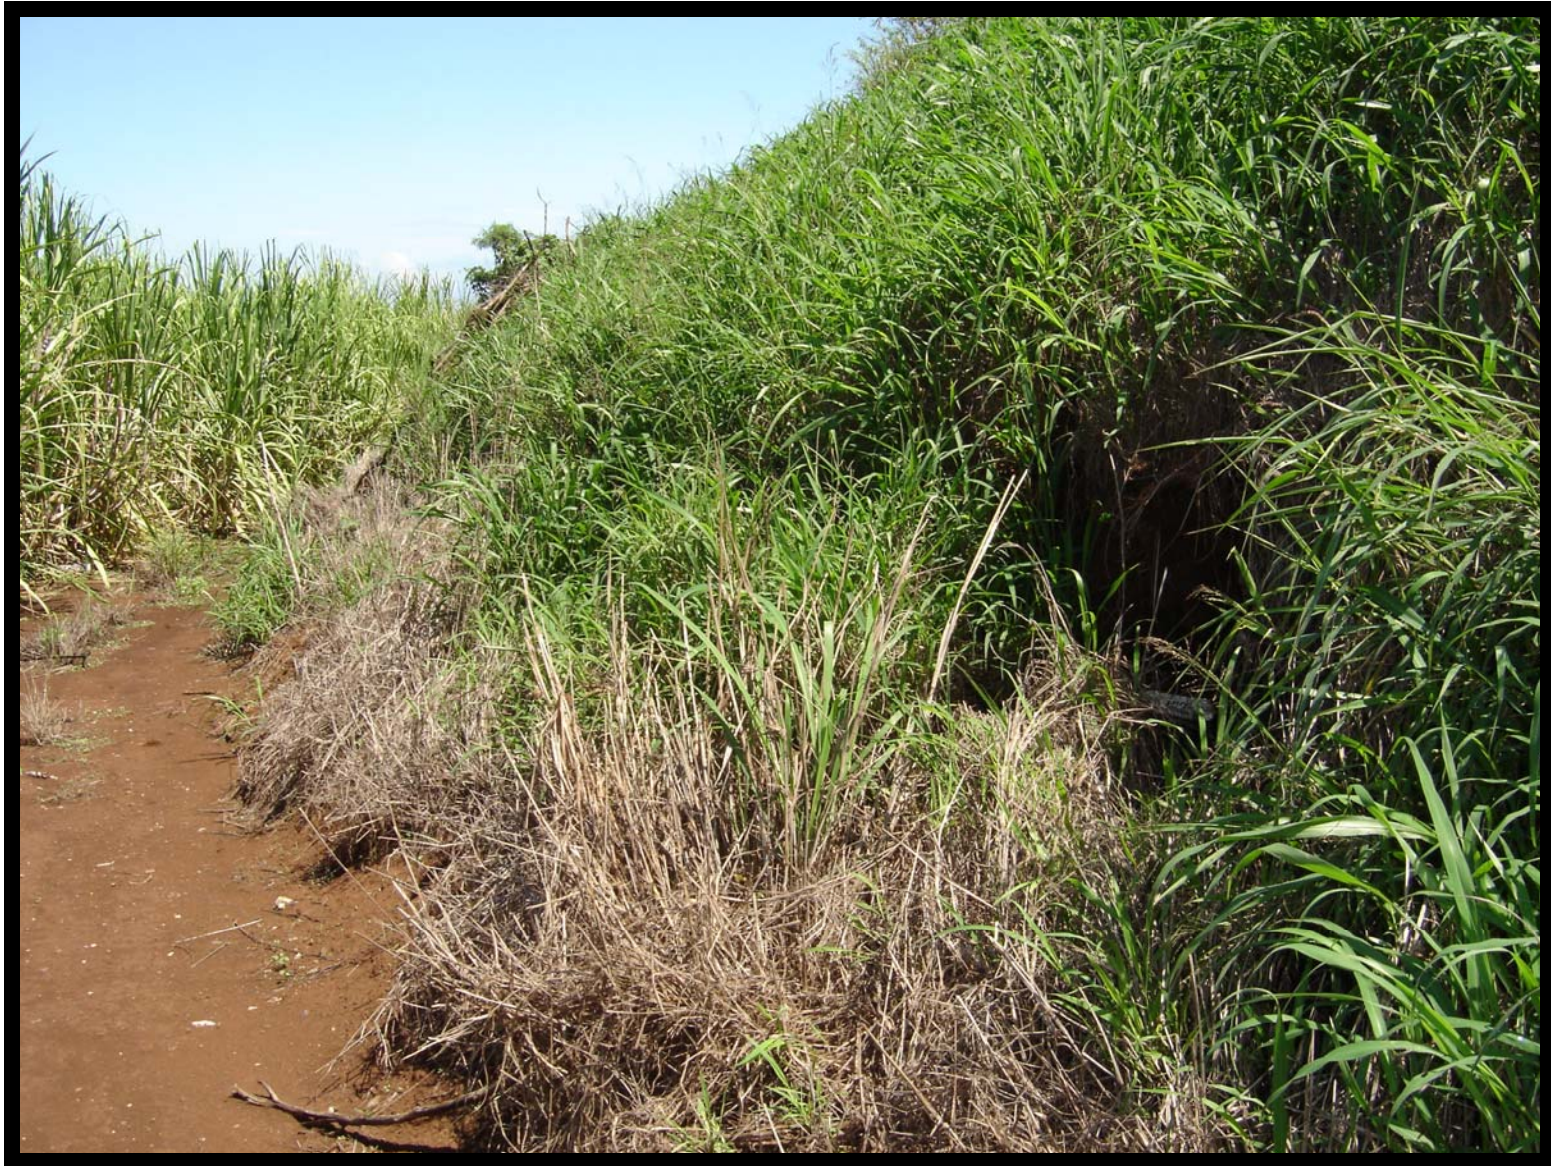
076 downstream slope with toe cut from road maintenance

Some toe areas were cut to maintain the access road. Material should be properly replaced.

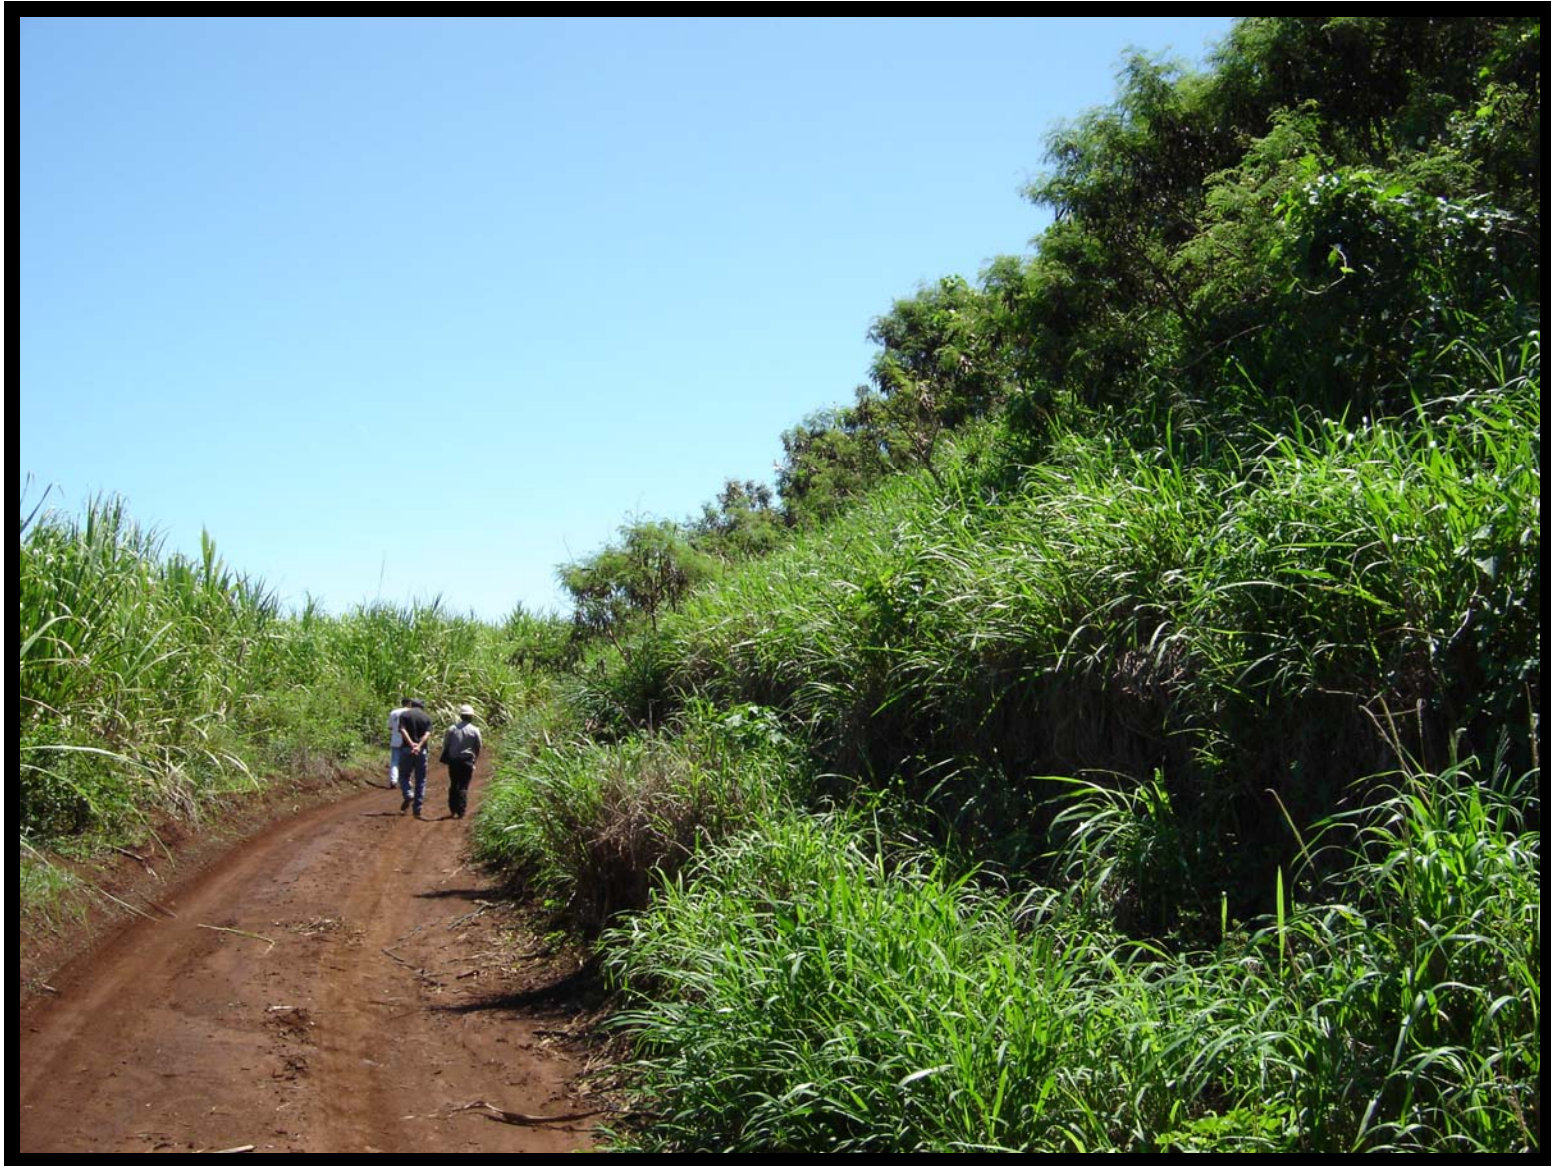
076 View of downstream slope of right embankment and access road.

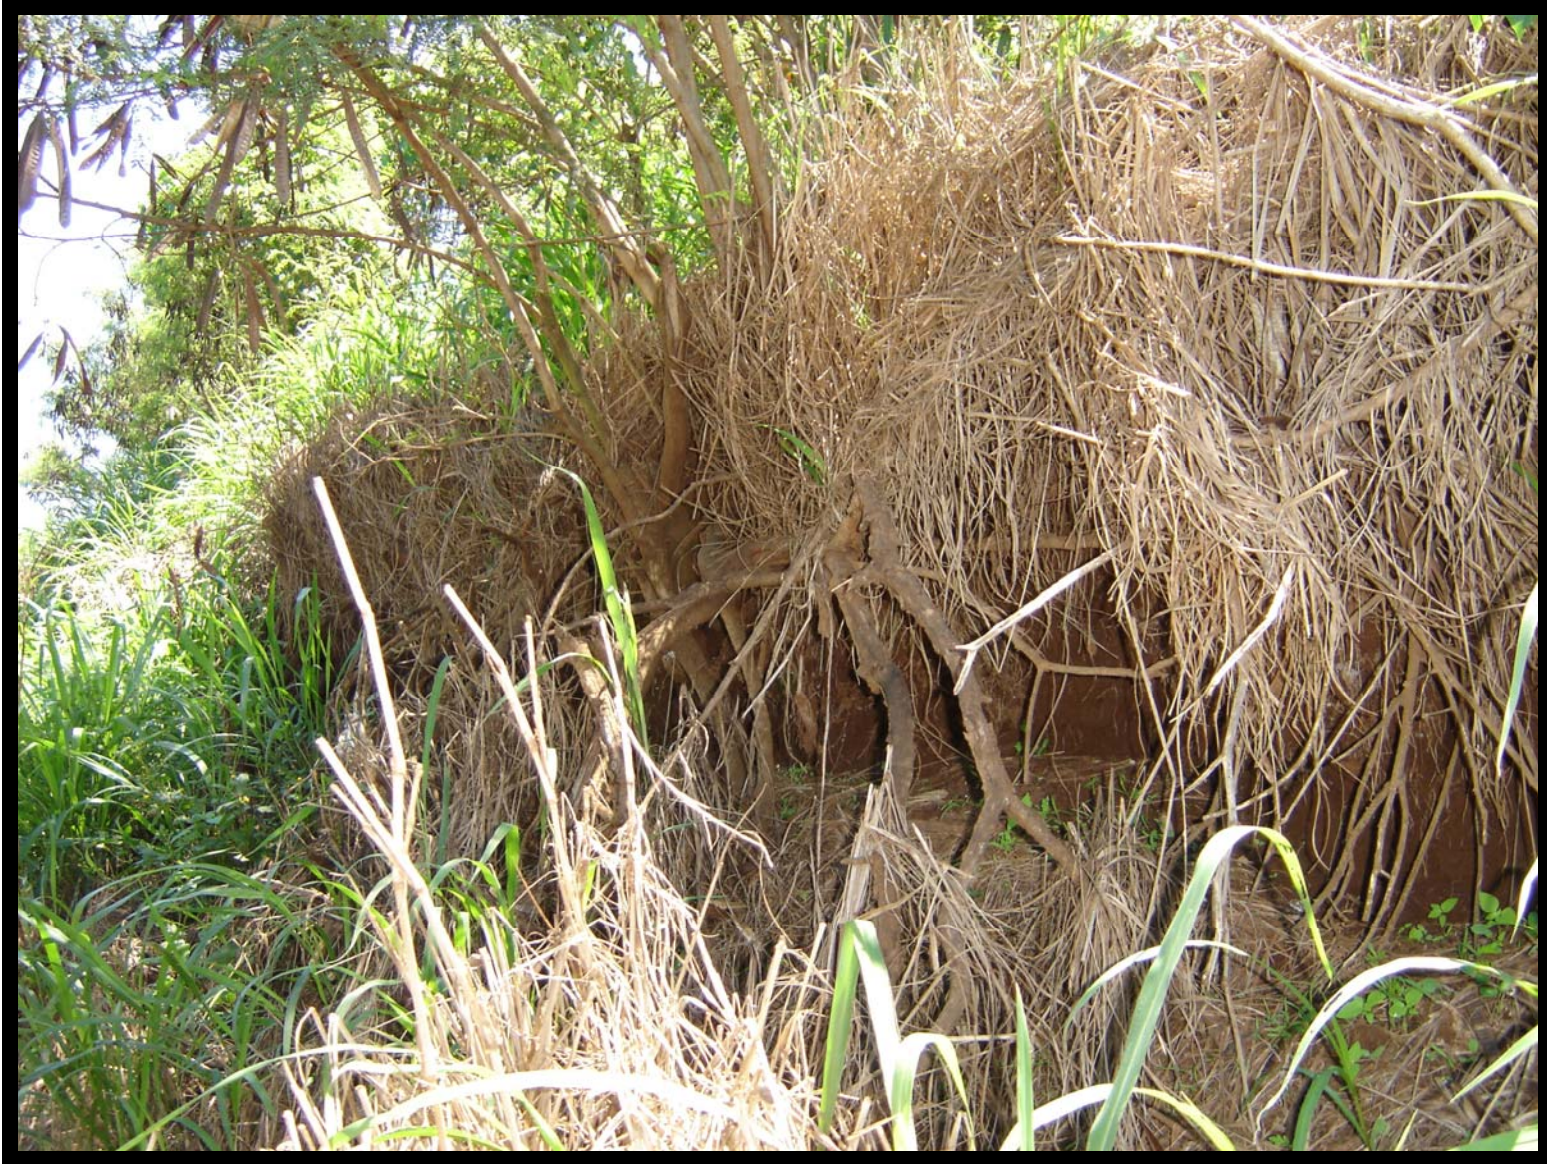
076 View of downstream toe cut from road maintenance and subsequent erosion

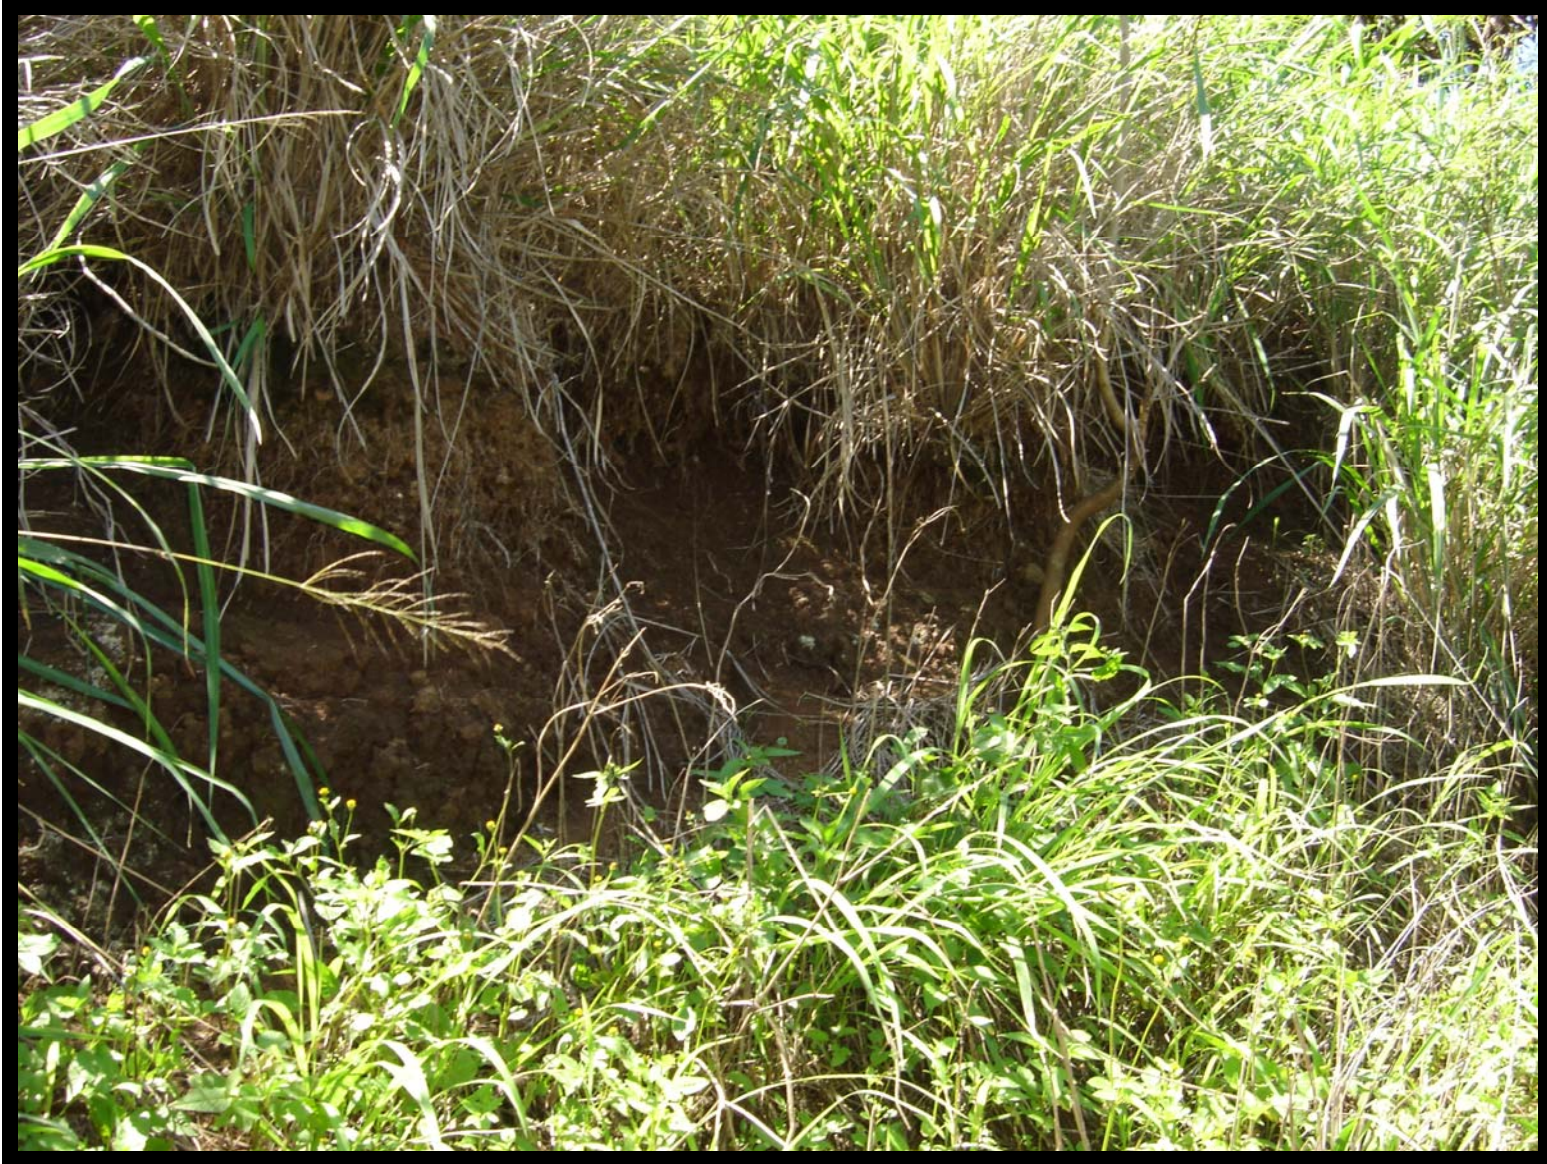
076 View of erosion downstream toe near downstream/right embankment junction

- a. The abutments/toe appeared to be in fair to poor condition and requires corrective action.
- b. Minor undercutting in discrete locations at the toe due to maintaining the access road was observed. Recommendation is to replace the material.

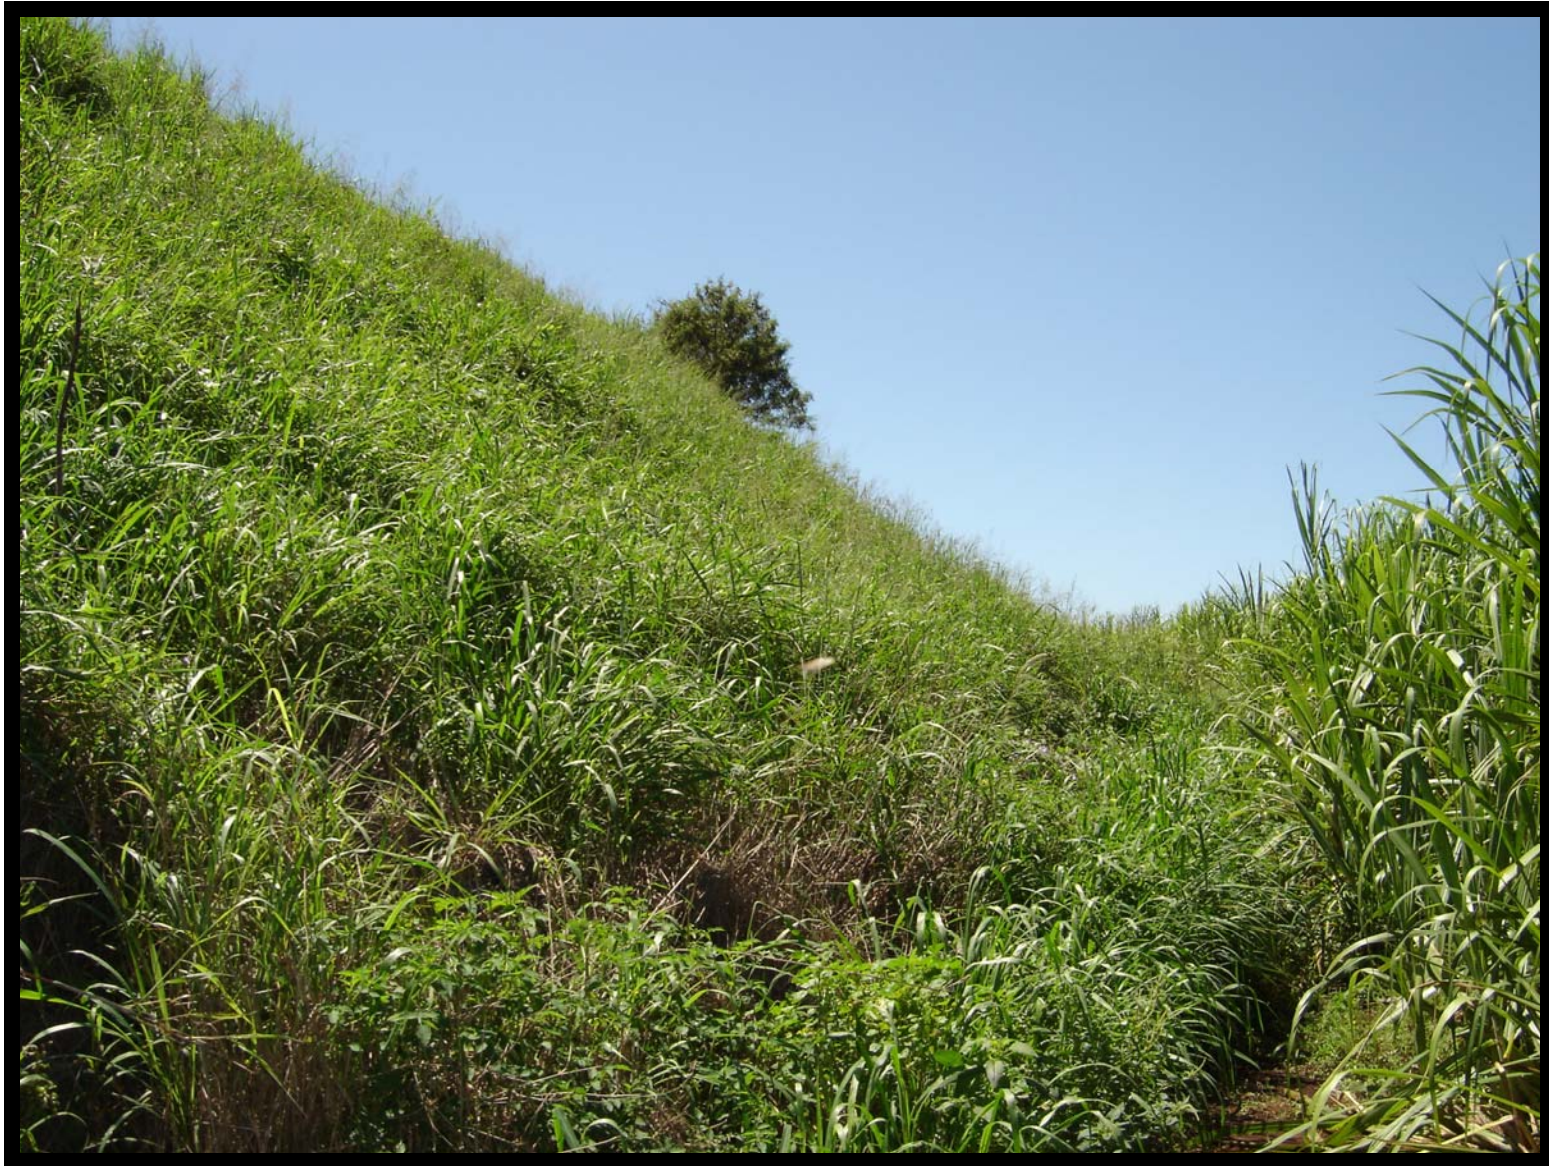
076 Downstream slope - cover along downstream slope looking toward left end of dam.

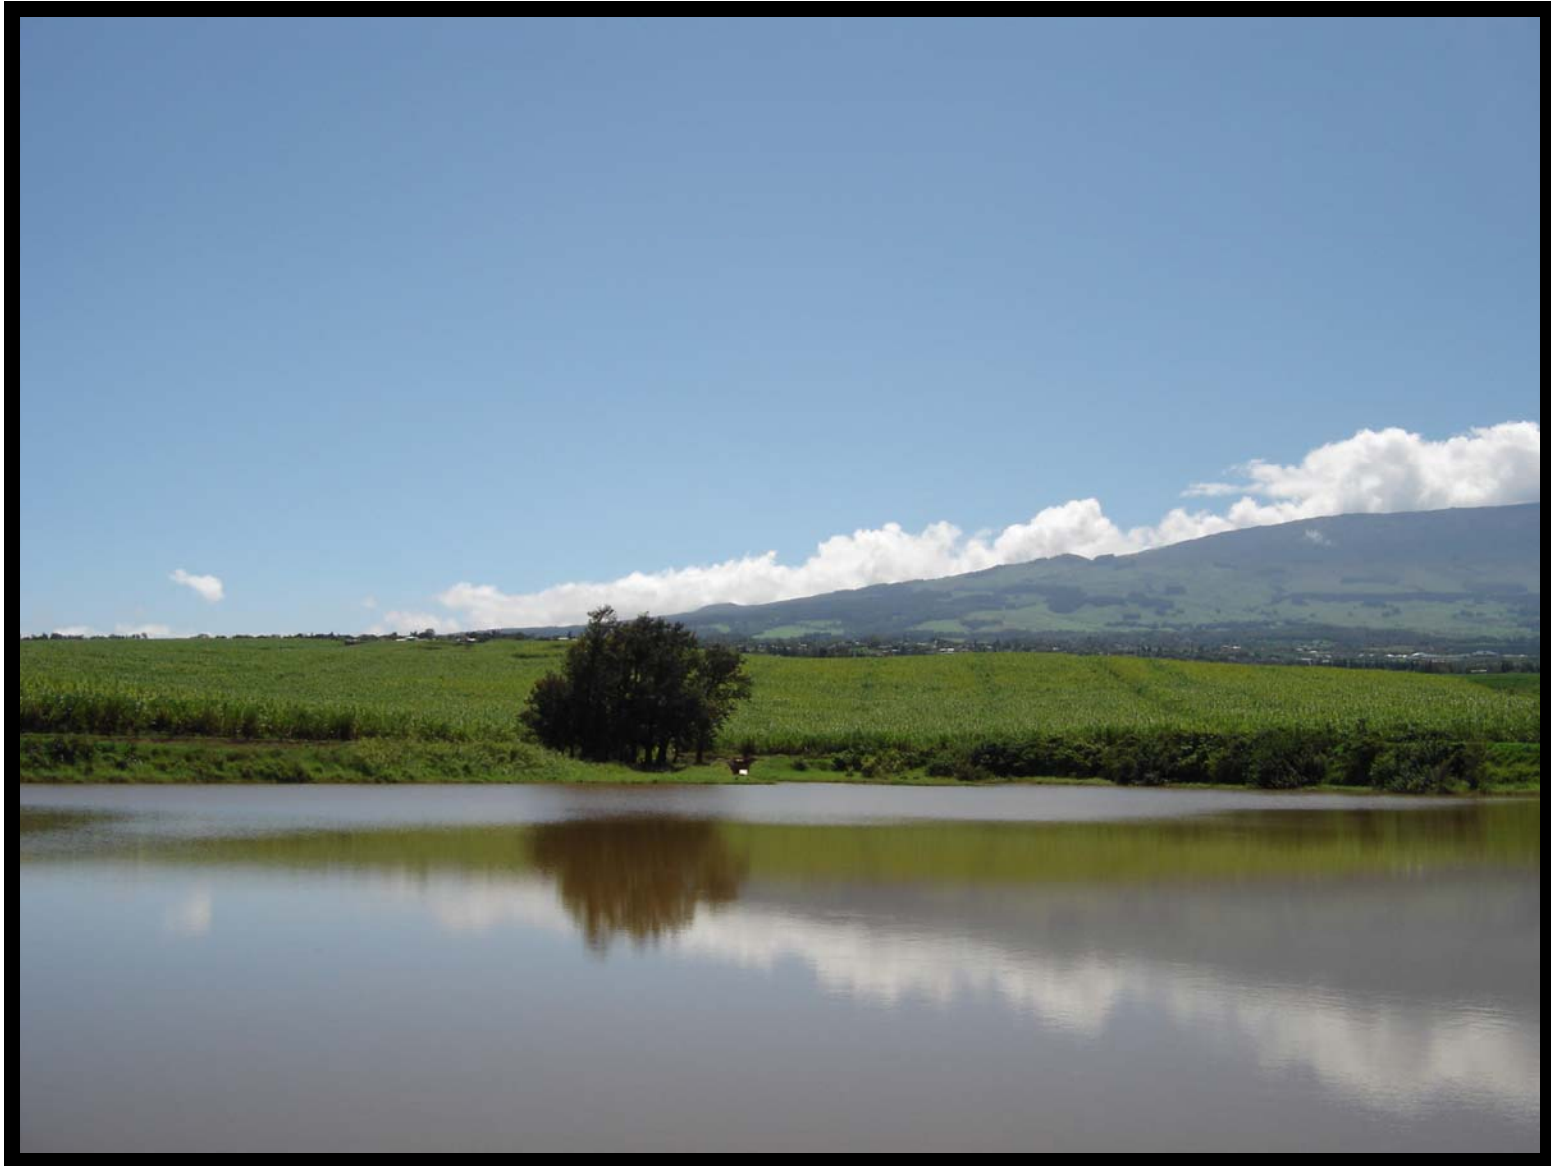
076 View of impoundment looking upstream toward inlet channel.

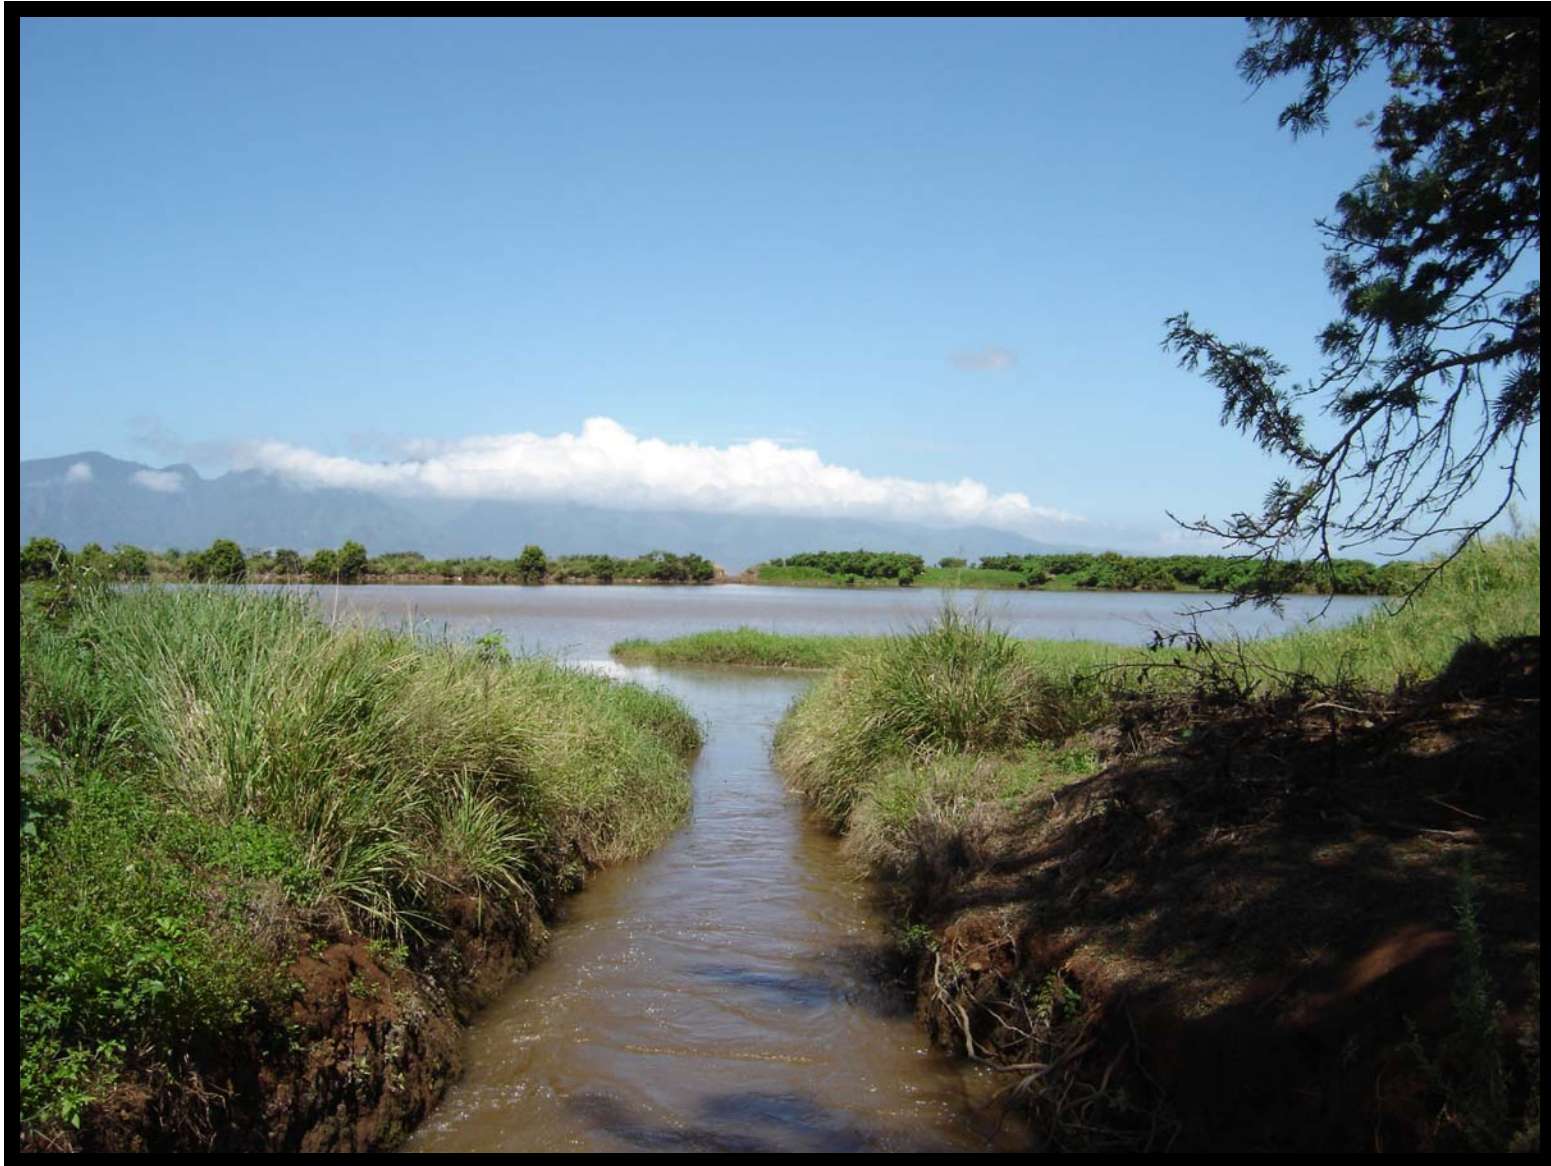
076 View of channel to from inlet to reservoir looking downstream

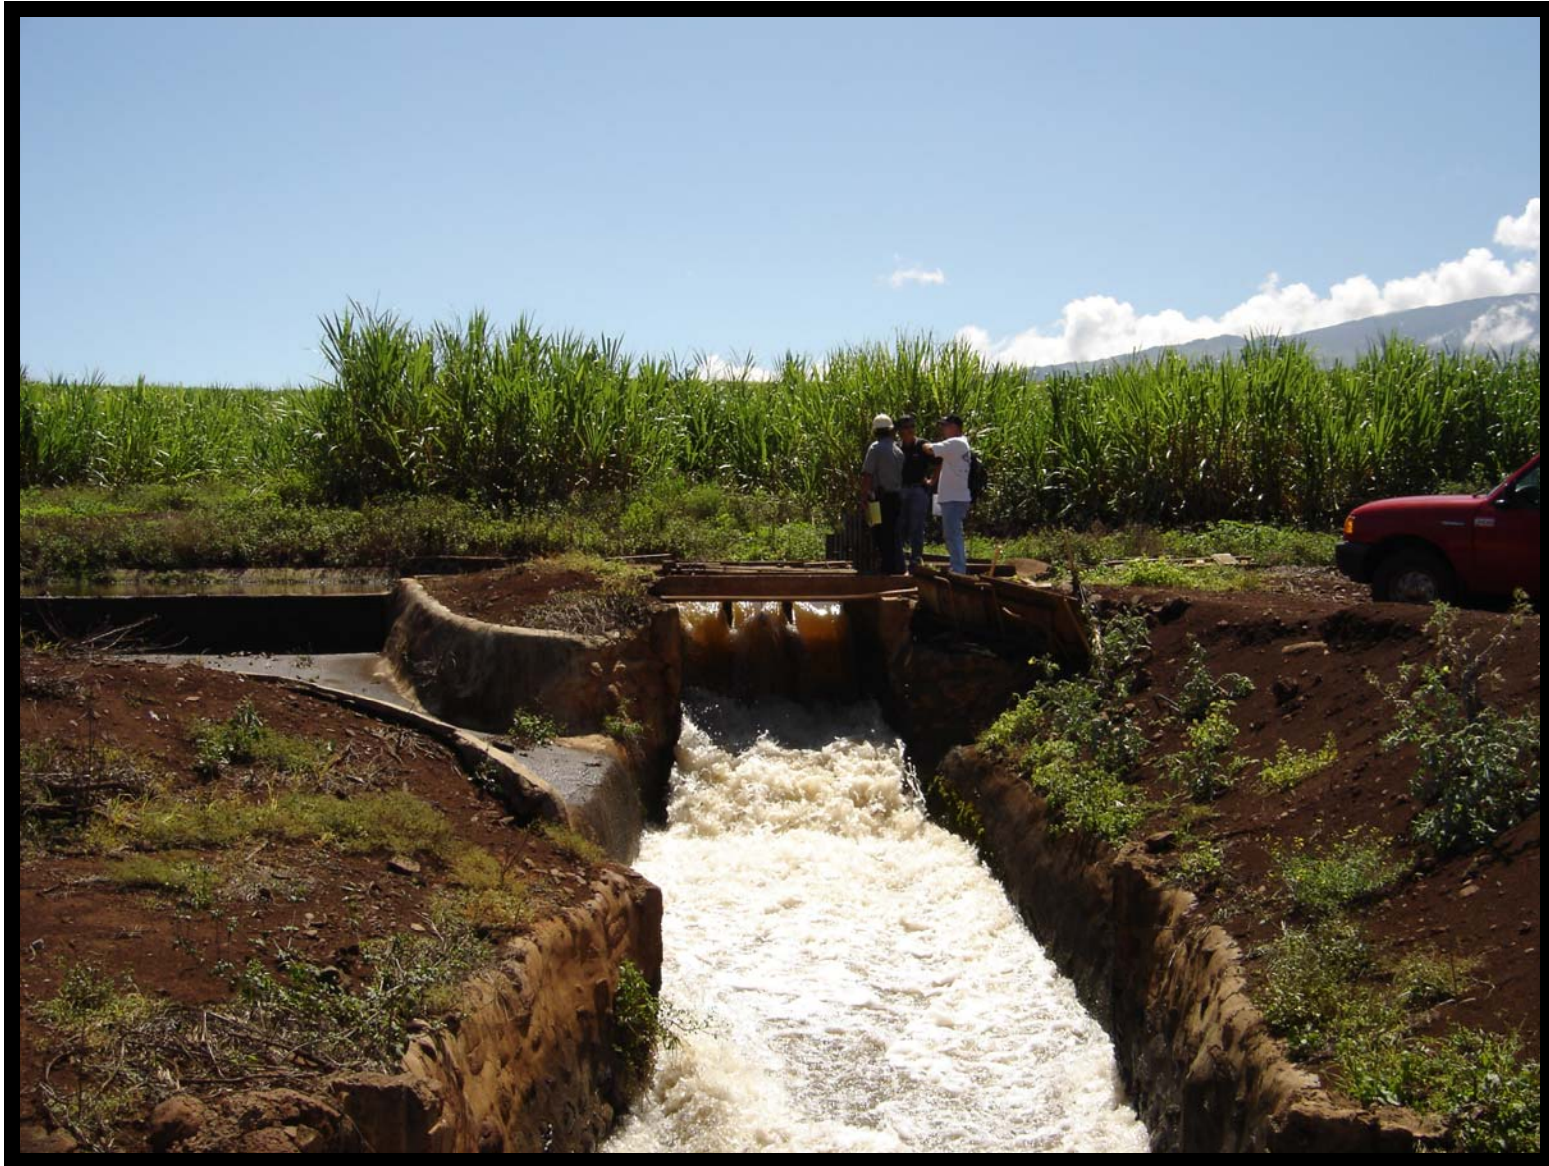
076 View of channel to from inlet to reservoir looking upstream

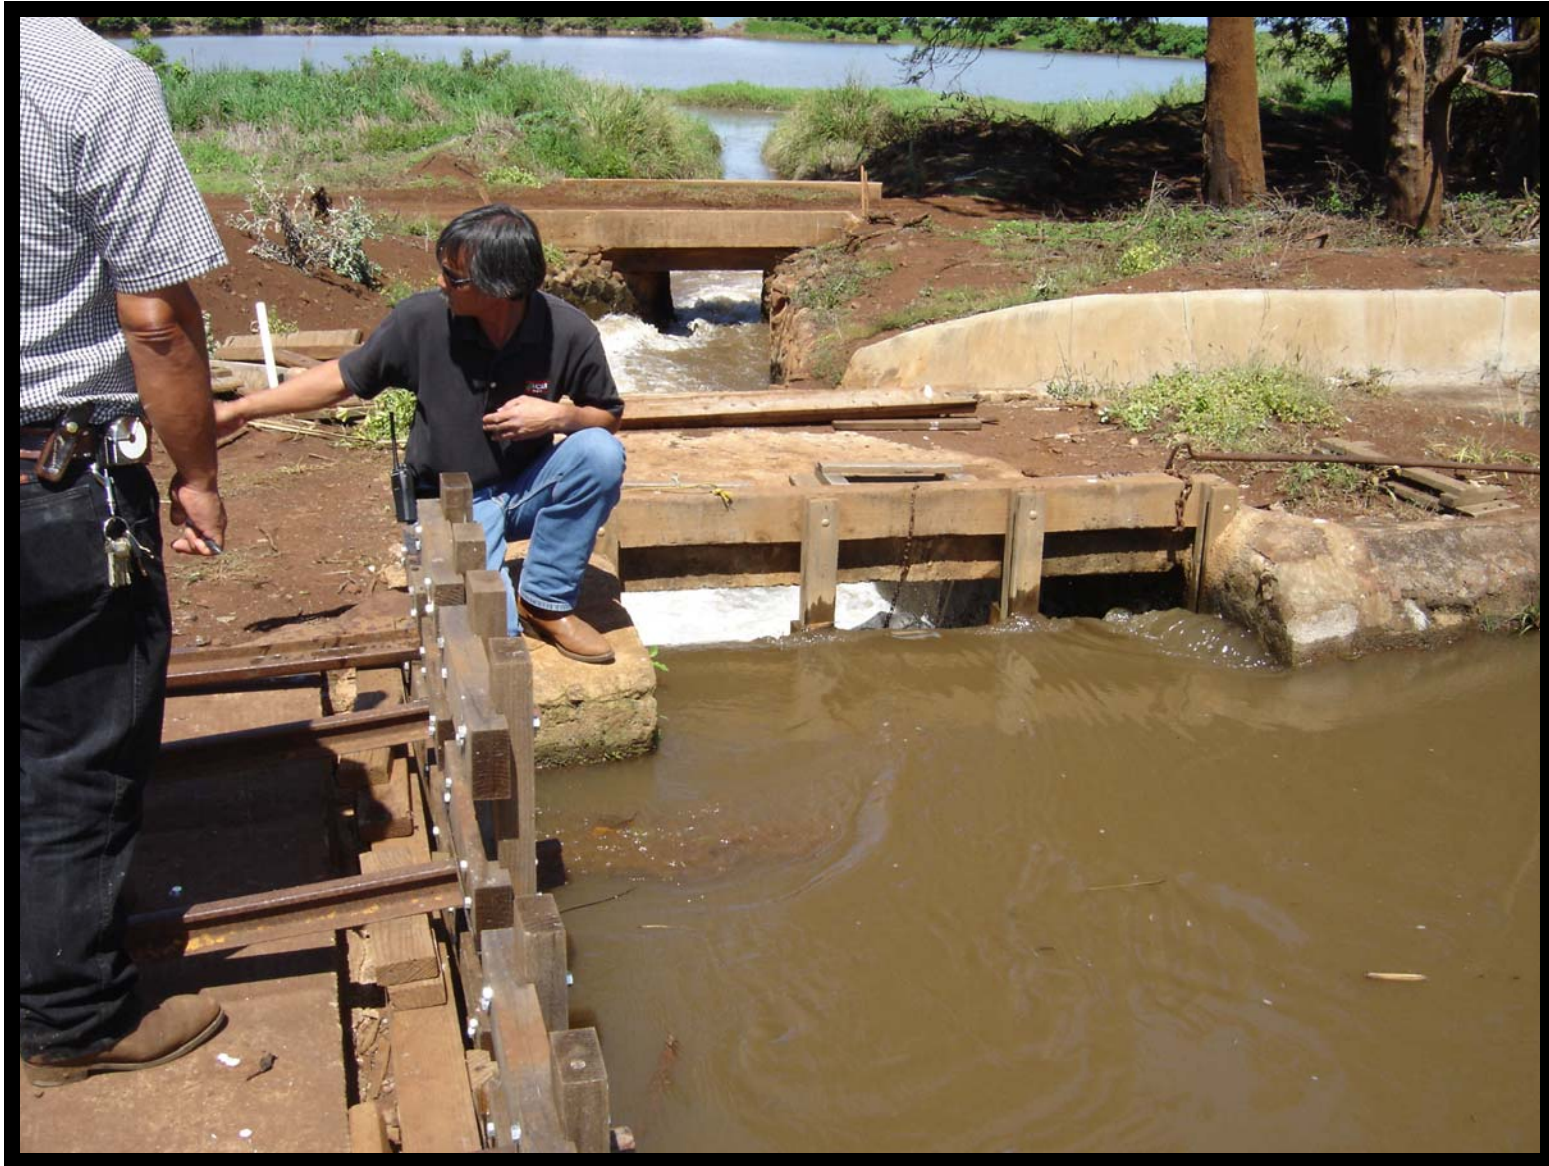
076 View of inlet entrance from diversion channel looking downstream

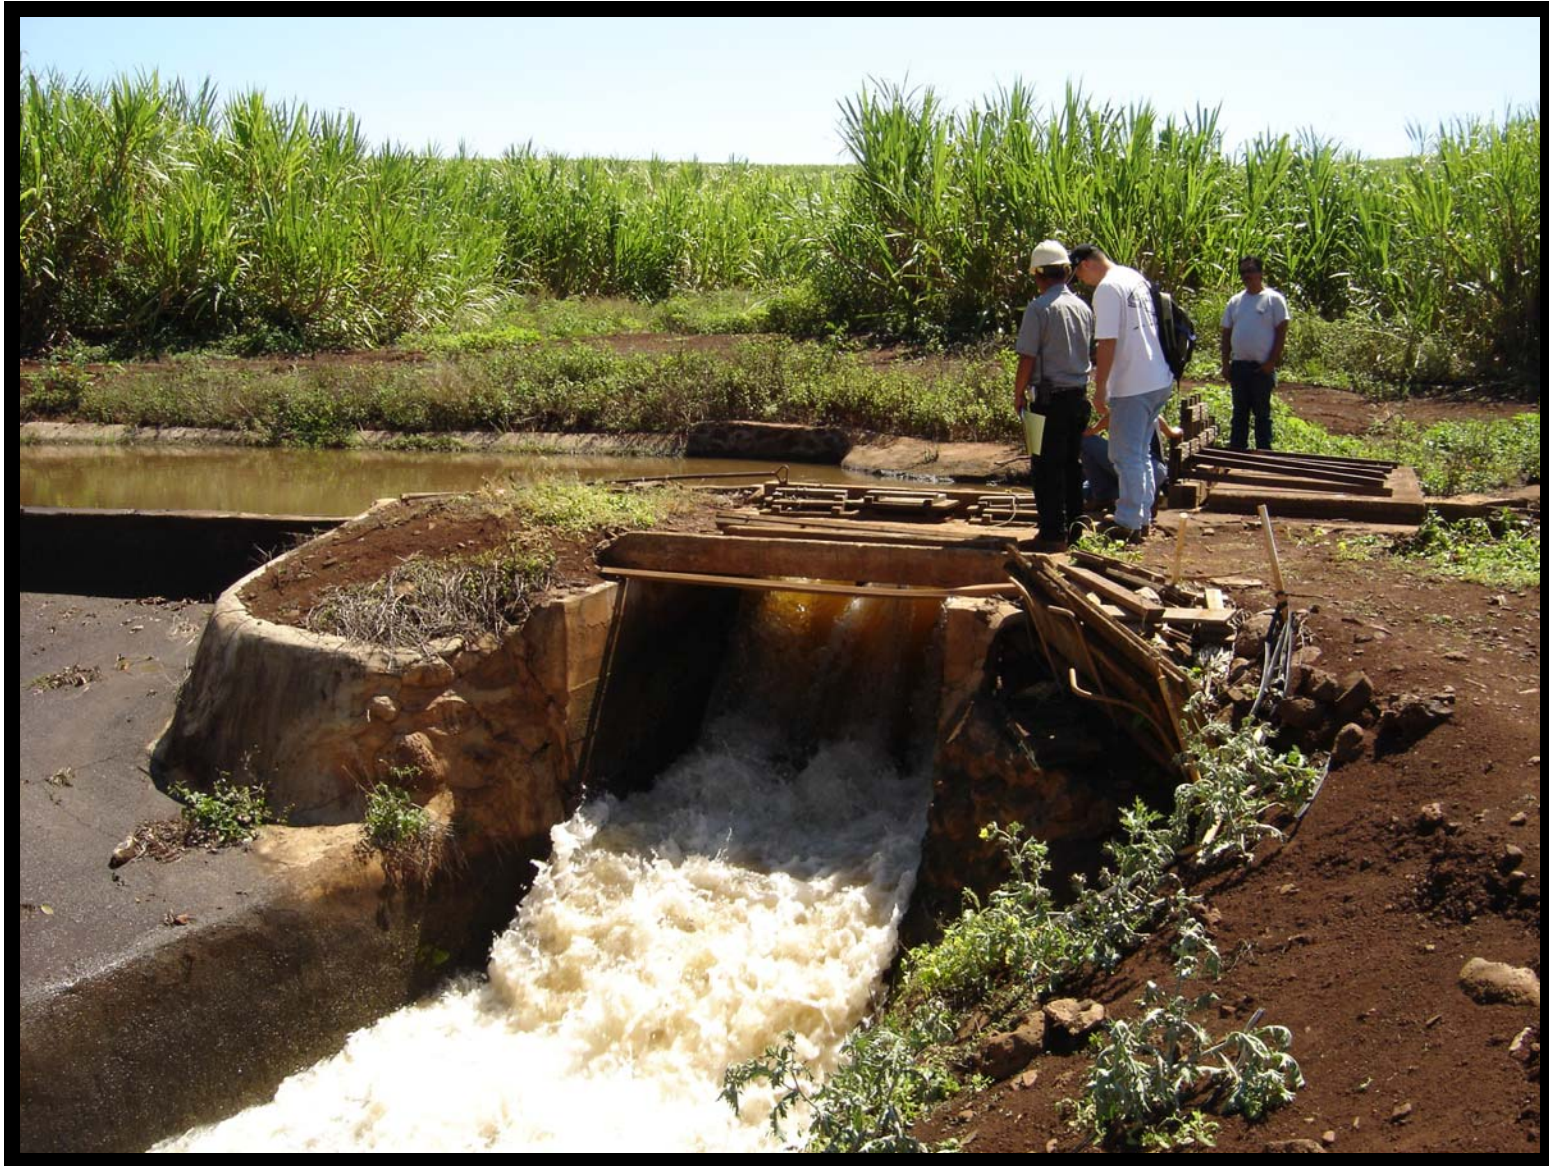
076 View of inlet flume looking upstream
